PROTECO LANDFILL SUPERFUND SITE
Peñuelas, Puerto Rico
Site Reconnaissance Visit Summary

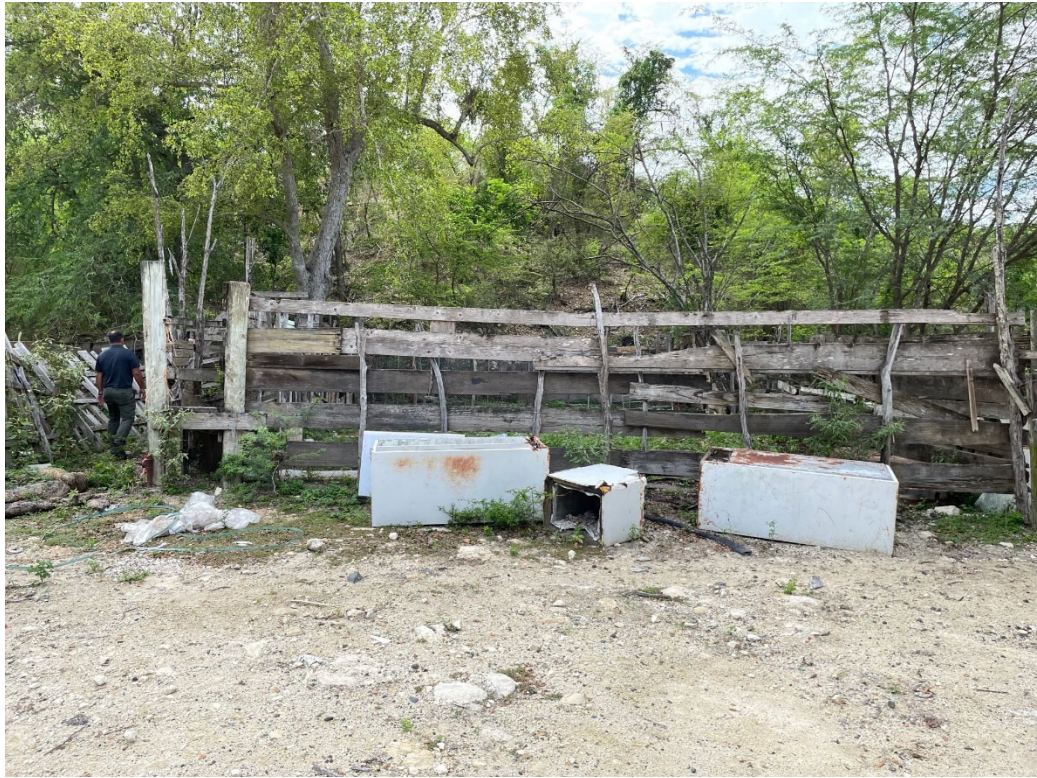
There were seven (7) horses present inside the Site fence near the west gate area. The horses were observed by the EPA representatives and the Group representatives. The horses remained in the general area of the animal pen and Corrective Action Management Unit (CAMU 9) during the SRV. The EPA representatives were shown the animal pen, loading chute and a barbed wire corral that are located near the west gate inside the Site. The EPA representatives were shown the abandoned refrigerators which the livestock owner uses to water his animals. Photos 1 through 4 show the livestock pen, abandoned refrigerators and horses in the west gate area.

Photo 1: Livestock Pen and Abandoned Refrigerators Near West Gate

The Group representatives asked for EPA's assurance that they will follow through with the livestock owner to have the animals removed from the Site. Zolymer Luna stated she would contact the livestock owner. The horses remained away from the group during the SRV.

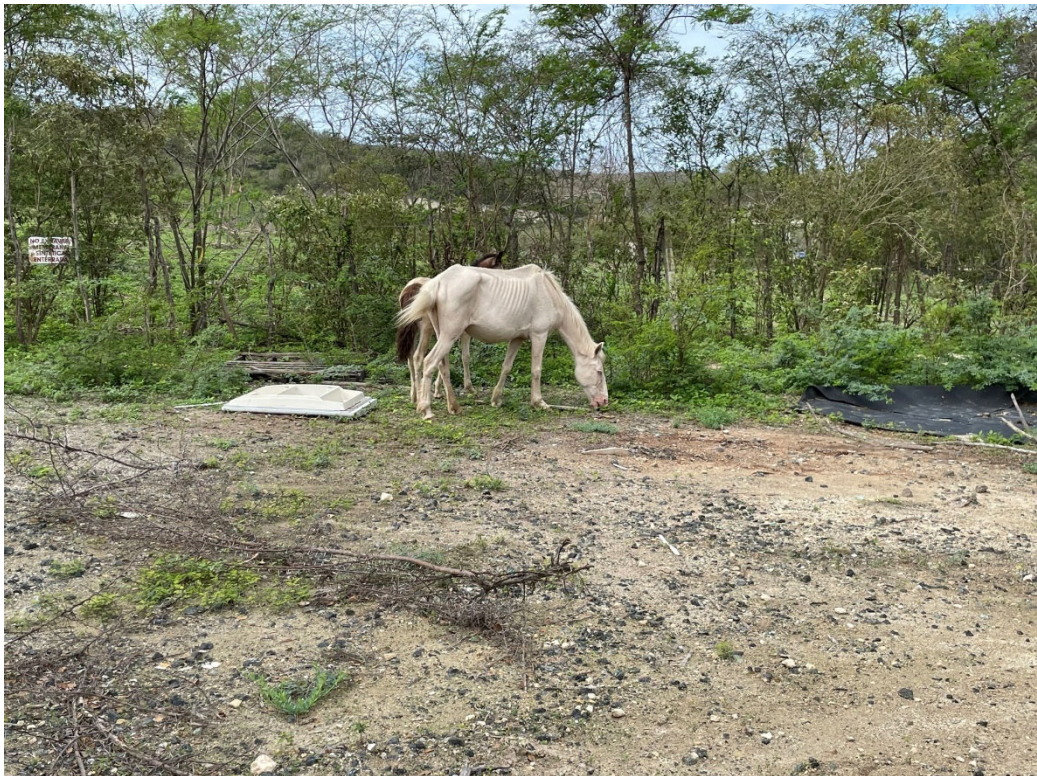
Photo 2: Horses and Debris Near Livestock Pen in West gate Area

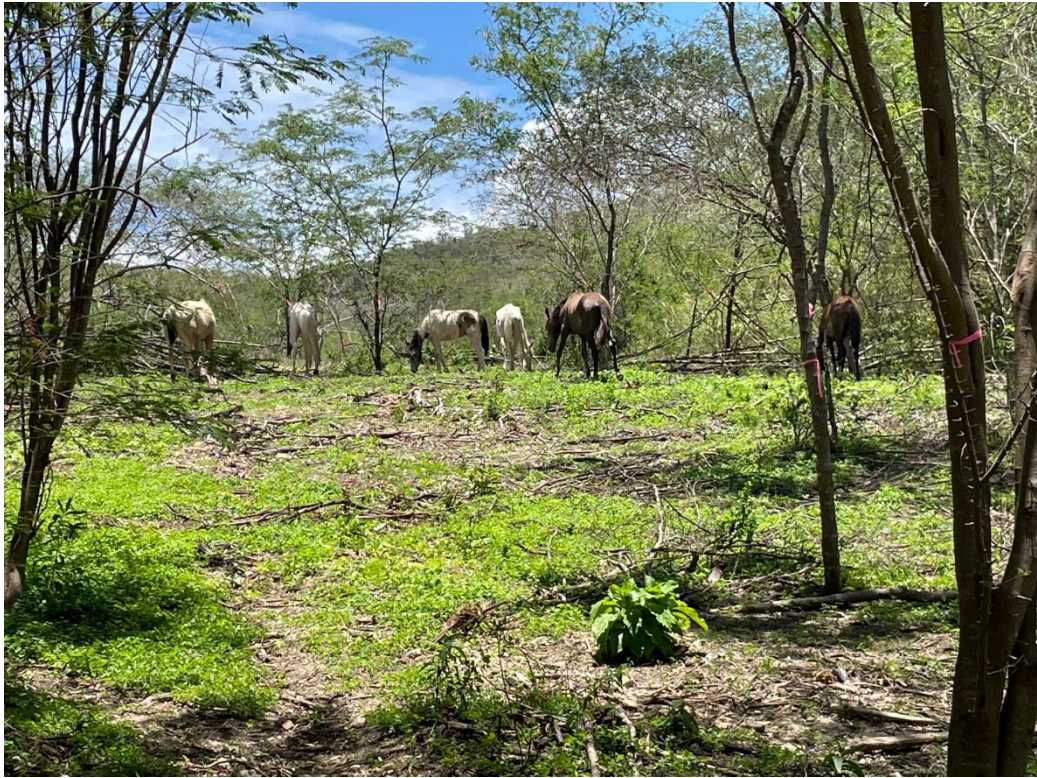
Photo 3: A Group of Six (6) Horses Near CAMU 9 and West Gate

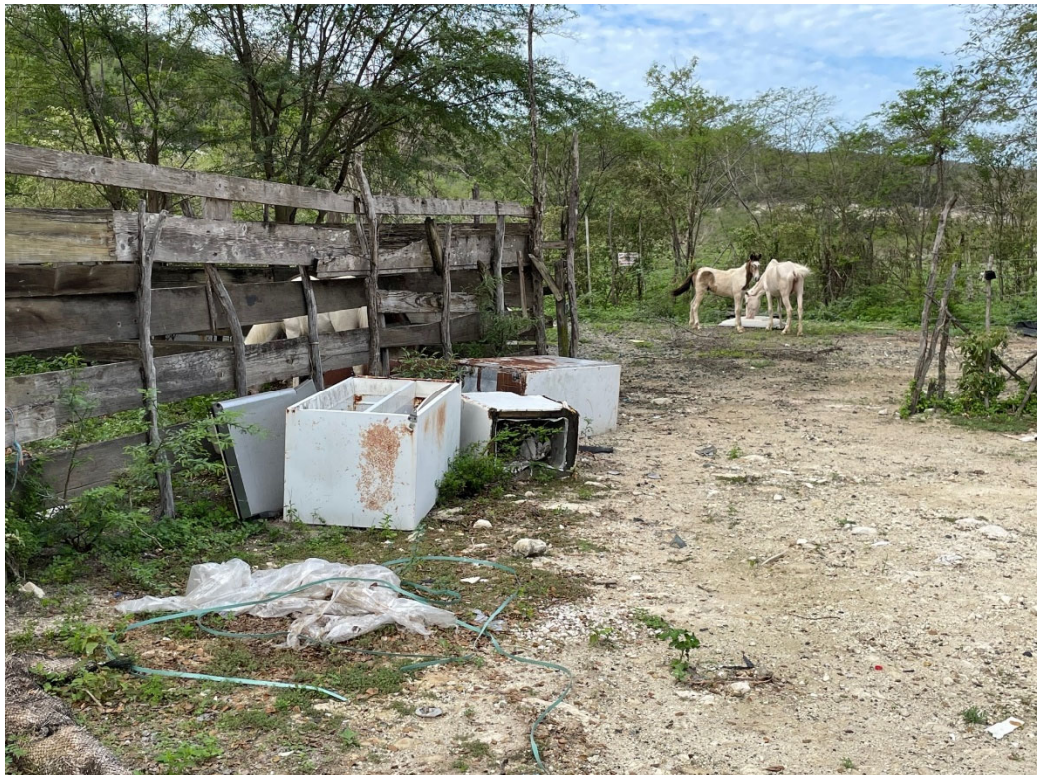
Photo 4: Livestock Pen, Abandoned Refrigerators and Horses Near West Gate

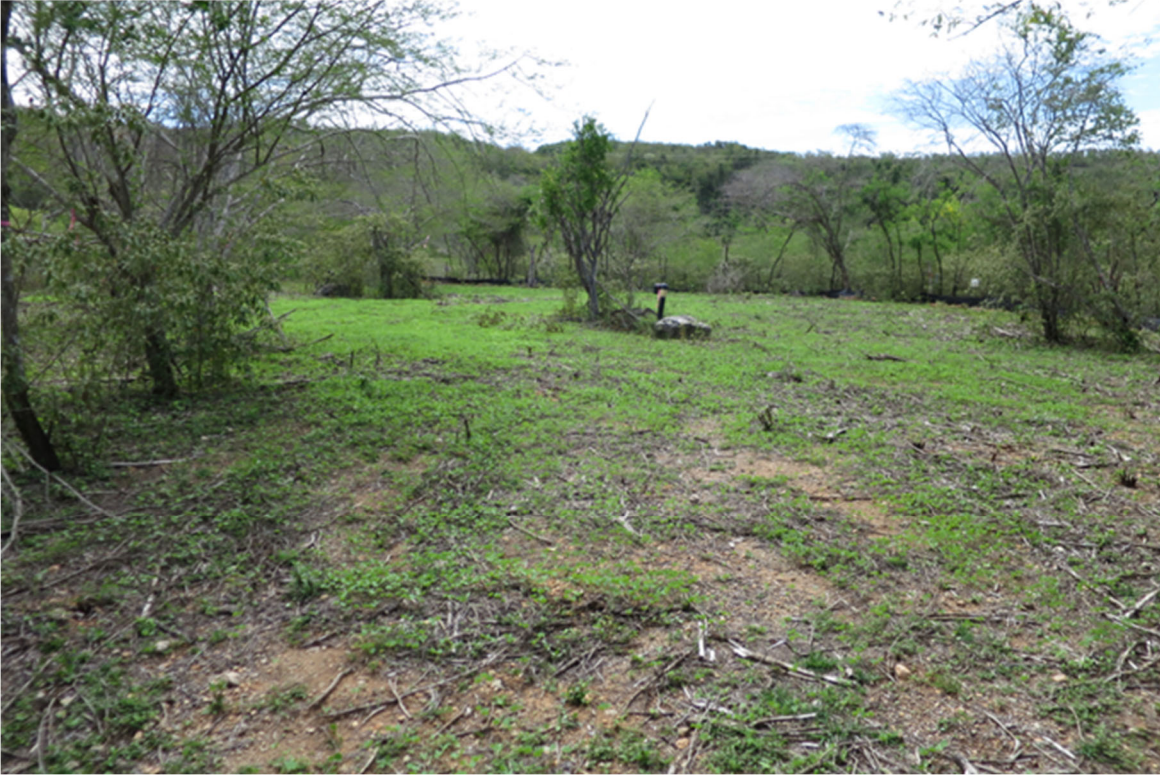
The SRV group began by walking from the west gate area to WU 5 which is reported to be a former drum burial area. Jaime Feliciano pointed out the survey stakes that marked the base of the WU to the group. Jaime also showed the remnants of an old electric transmission tower location on the north side of WU 5 to the group. Old insulators, guy wires and other related debris are present in this location. Photo 5 shows a general view of WU 5.

Photo 5: General View of WU 5

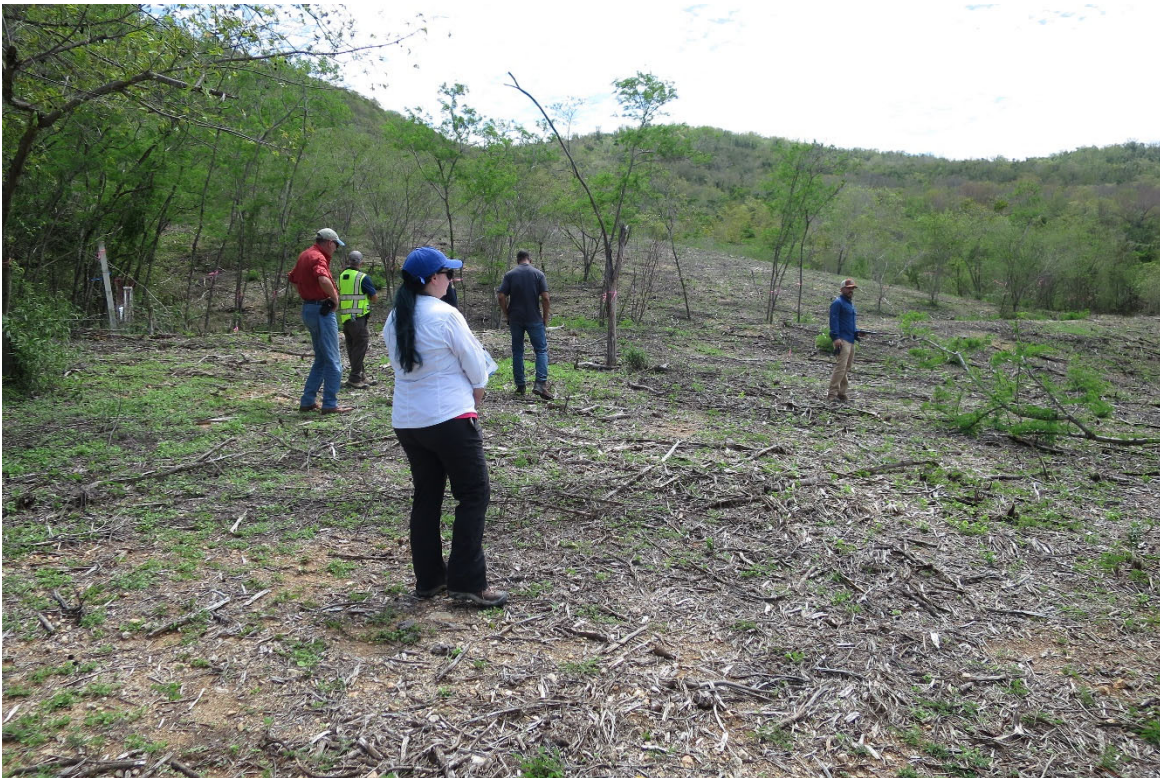
The group walked from WU 5 to WU 1. There is an old access gate present in the fence on the north side of WU 1. The broken strand of barbed wire observed by EPA on April 14, 2022, was adjacent to this gate. It would appear that this strand of wire was broken by a tree limb because the brush on the outside of the fence is too dense for the livestock to pass through to access it. The broken strand of wire will be repaired during a future Site inspection visit. Photo 6 shows a general view of WU 1.

Photo 6: General View of WU 1 (WU 2 and WU 3 in background)

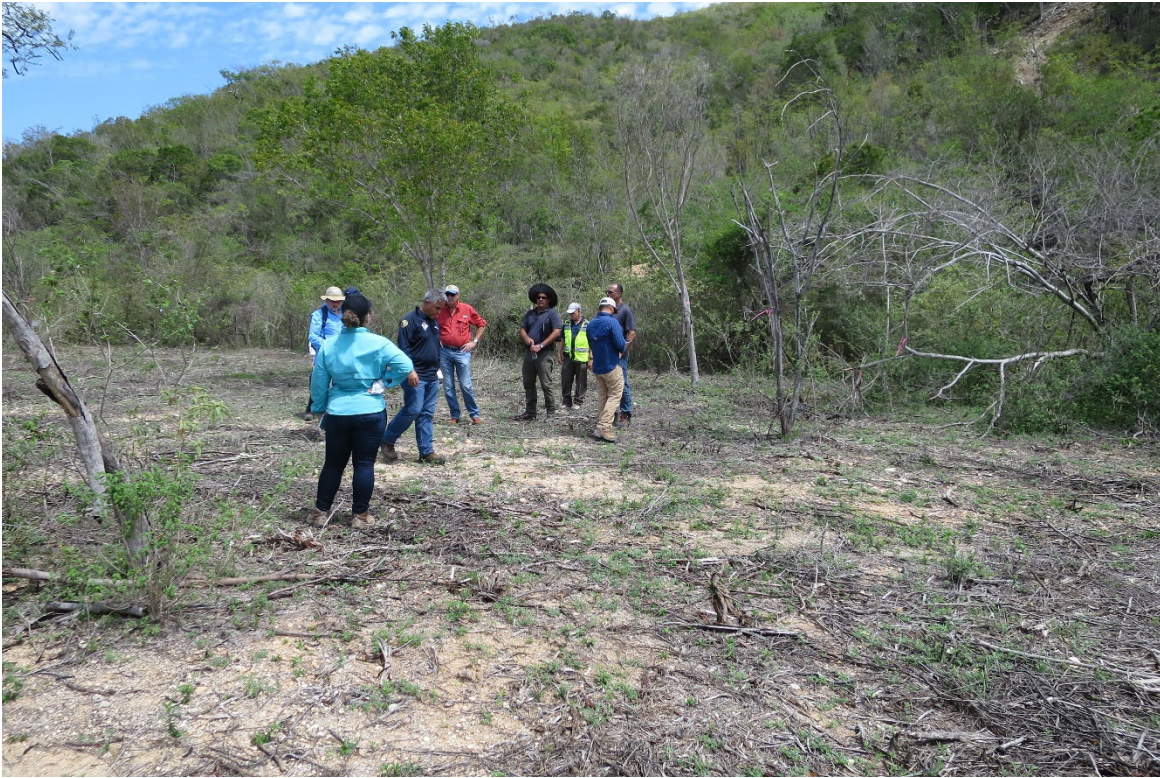
The group walked from WU 1 to WU 2 and WU 3. The 2019 HRS Report (Weston 2019) stated that WU 2 and WU 3 were to be capped at the same time and both WUs share a single continuous cap. WU 2 and WU 3 are at the highest elevation on the western portion of the Site. These WUs were reported to be drum disposal areas. Yellow flagging to the northeast of WU 2 and WU 3 which marked a potential PR Nightjar nesting area was shown to the group. Photo 7 shows a general view of WU 2 and WU 3.

Photo 7: General View of WU 2 and WU 3

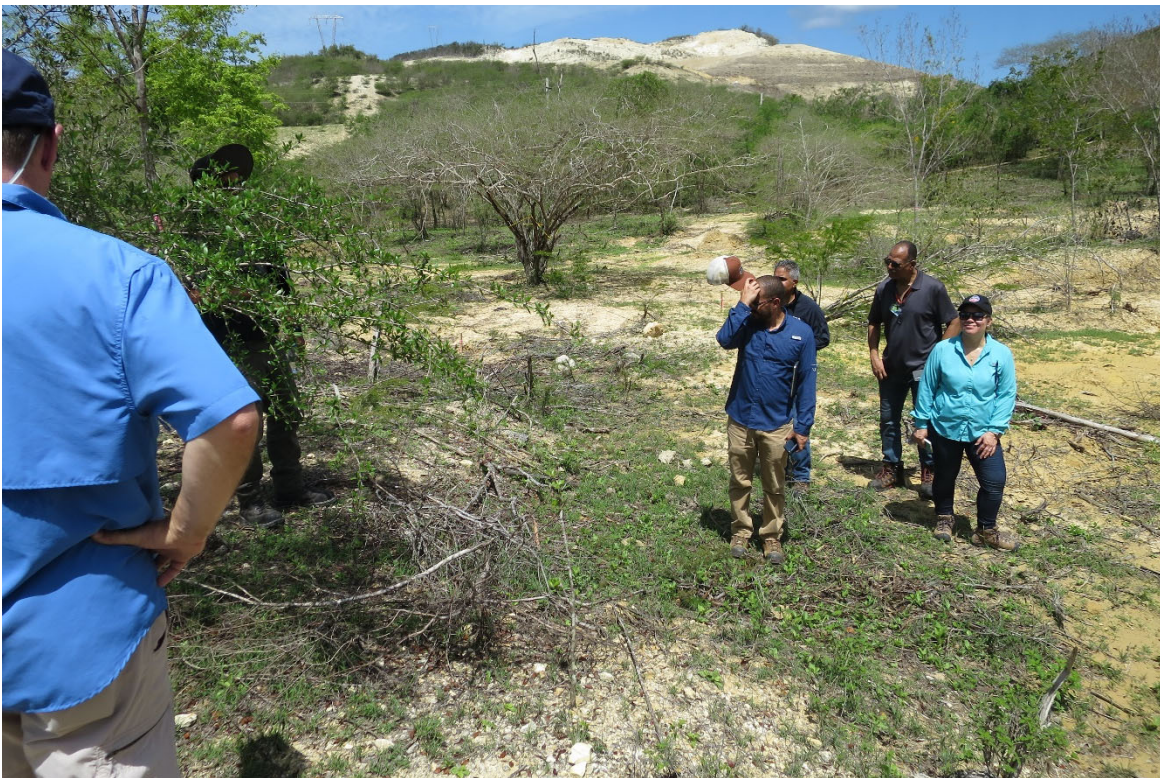
The group walked from WU 2 and WU 3 to WU 7. WU 7 was reported (Weston 2019) to be a former neutralization pit. The neutralization pit was used to alter the pH level of potentially corrosive wastes by

dilution or chemical neutralization so the treated material could be stored and/or transported in compliance with transportation and/or environmental regulations. The neutralization pit was reported (Weston 2019) to have been excavated into the soil and did not have a liner. Photo 8 shows a general view of WU 7.

Photo 8: General View of WU 7 (EC Waste in background)

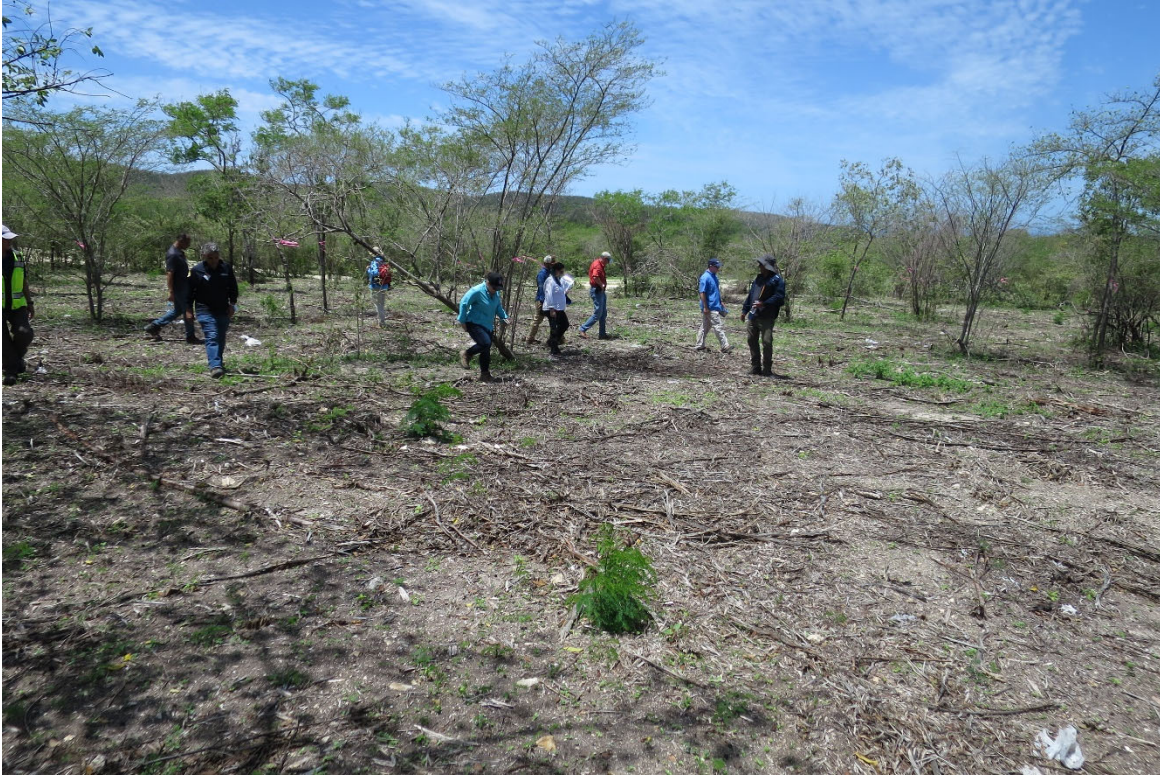
The group walked from WU 7 to WU 14. WU 14's eastern limit is the boundary with Ecosystems. WU 14 is the largest of the WUs and encompasses approximately eleven (11) acres. WU 14 is at the highest elevation on the eastern portion of the Site. WU 14 is reported (Weston 2019) to be a non-hazardous unit. Photo 9 shows a general view of WU 14.

Photo 9: General View of WU 14

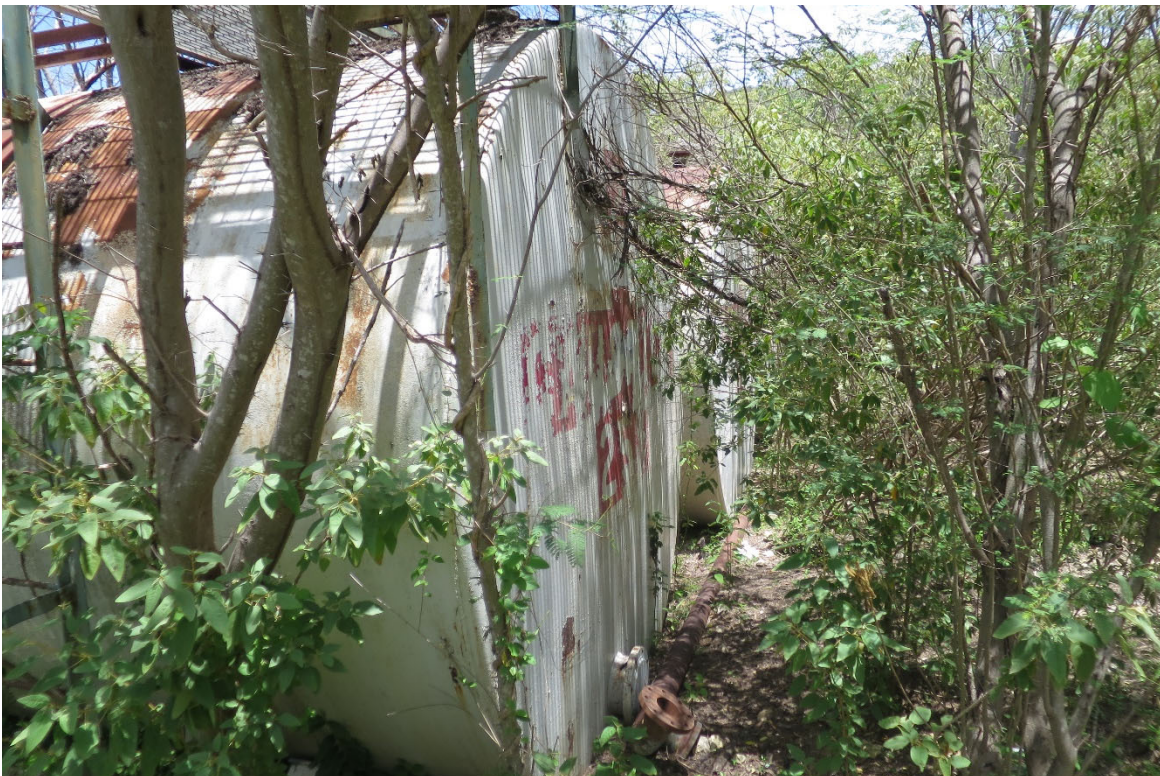
The group walked to the four (4) ASTs located across the access road from the southwest corner of WU 14 and to the east of the reported (Weston 2019) location for WU 8. The ASTs lie horizontally and have the approximate dimensions of 10-feet in diameter by 50-feet in length (estimated 30,000-gallon capacity each). In a September 23, 2005 Site Reassessment letter from the Puerto Rico Environmental Quality Board (EQB) to the USEPA included as an appendix in the 2019 HRS Report, it was reported that these ASTs were used to collect non-hazardous wastewaters and were emptied and cleaned before PROTECO ceased their operations. No attempt was made during the SRV to open or inspect the ASTs to determine if any liquids were present. Photo 10 shows a partial view of the AST area.

Photo 10: Partial View of AST Area

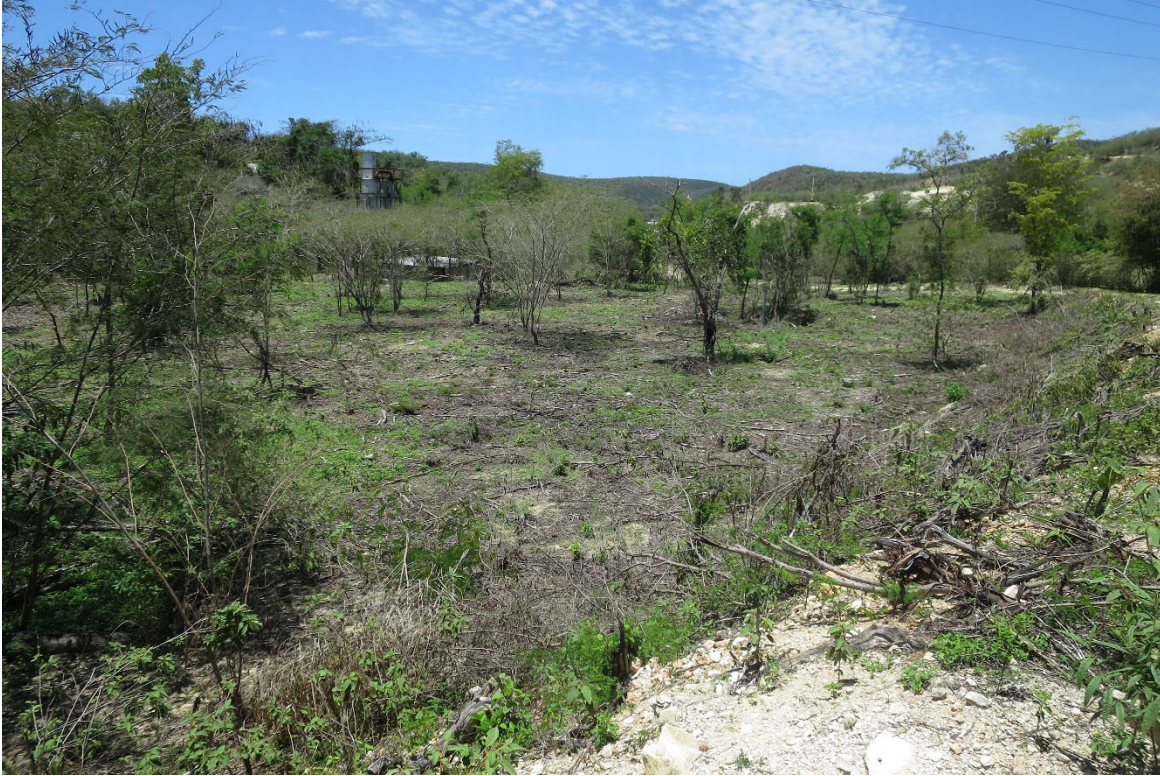
The group walked from the ASTs to the reported (Weston 2019) general location of WU 8. No visual indicators are present to define the location of WU 8. No survey data for WU 8 was contained in the HRS Report (Weston 2019). Since there is no physical/visual indication for the location of WU 8 it was not possible for Geosyntec to place survey stakes for this WU with any reasonable degree of certainty. A small mound of soil with apparent liner material is located to the west of the reported WU 8 location. However, at this time it is not possible to know if this material was associated with WU 8. Photo 11 shows a general view of reported location of WU 8.

Photo 11: General View of Reported Location of WU 8

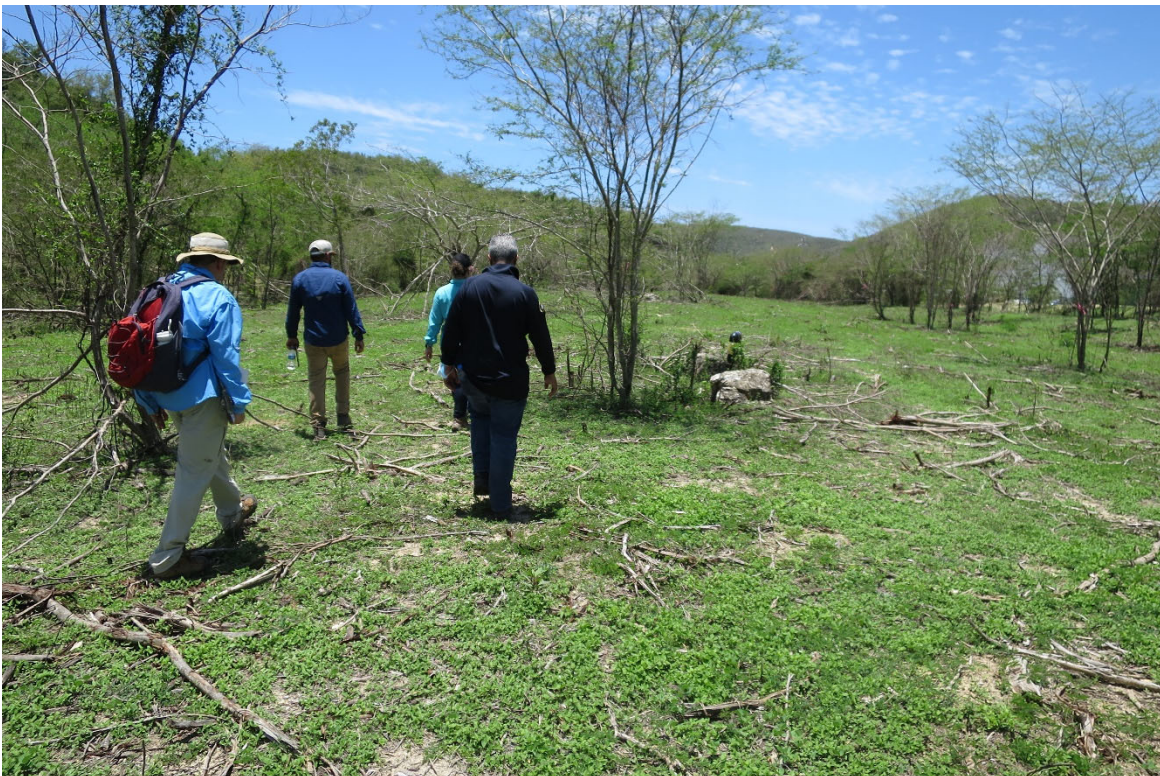
The group walked from the WU 8 area past the livestock pen and barbed wire corral to CAMU 9. Horses were present near CAMU 9 during this portion of the SRV. CAMU 9 is reported (Weston 2019) to include the former oil evaporation pond and Waste Units (WUs) 10, 11, 12 and 16. All of these WUs are located under a single continuous cap. A small concrete structure located on the west flank of CAMU 9 is reported (Weston 2019) to have been used as a leachate pump house. Gas vents are located along the crest of CAMU 9. Photo 12 shows a general view of CAMU 9.

Photo 12: General View of CAMU 9

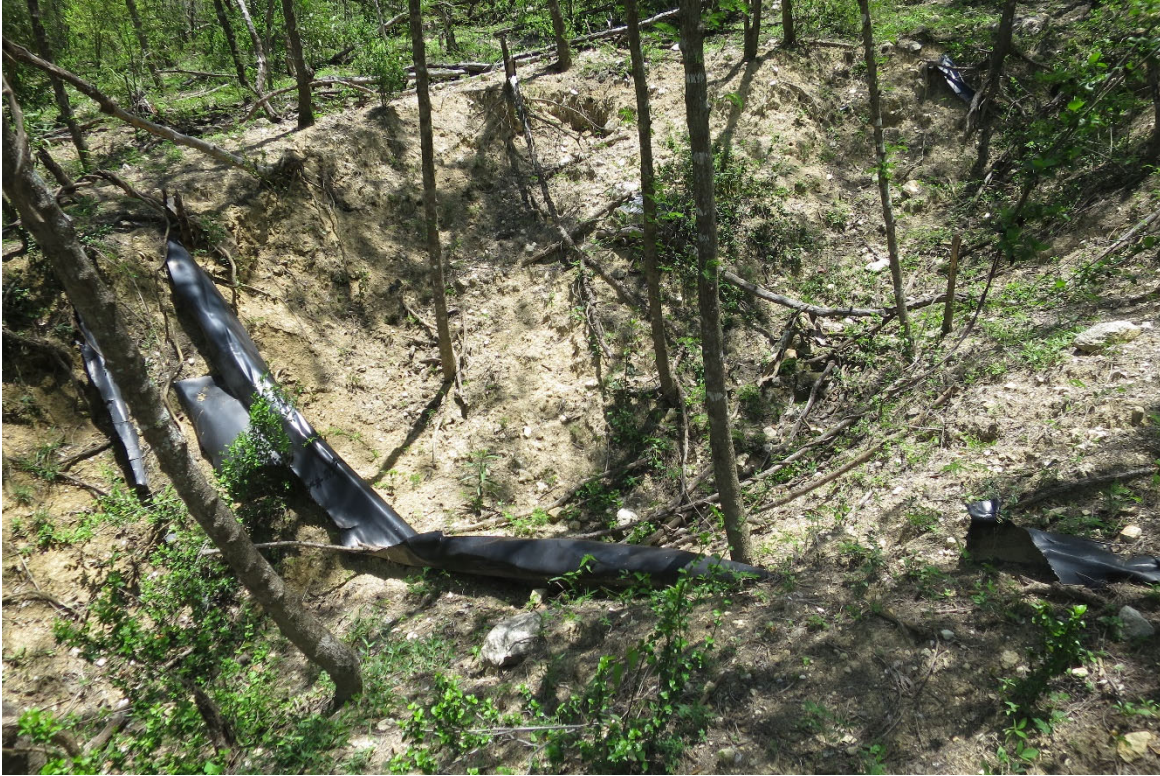
The group walked to WU 13 which is located to the east-southeast of CAMU 9. An erosion area is located on the west flank of WU 13. Liner material appears to be exposed in this erosion area (see photo 13).

Photo 13: View of Erosion Area on Side Slope of WU 13

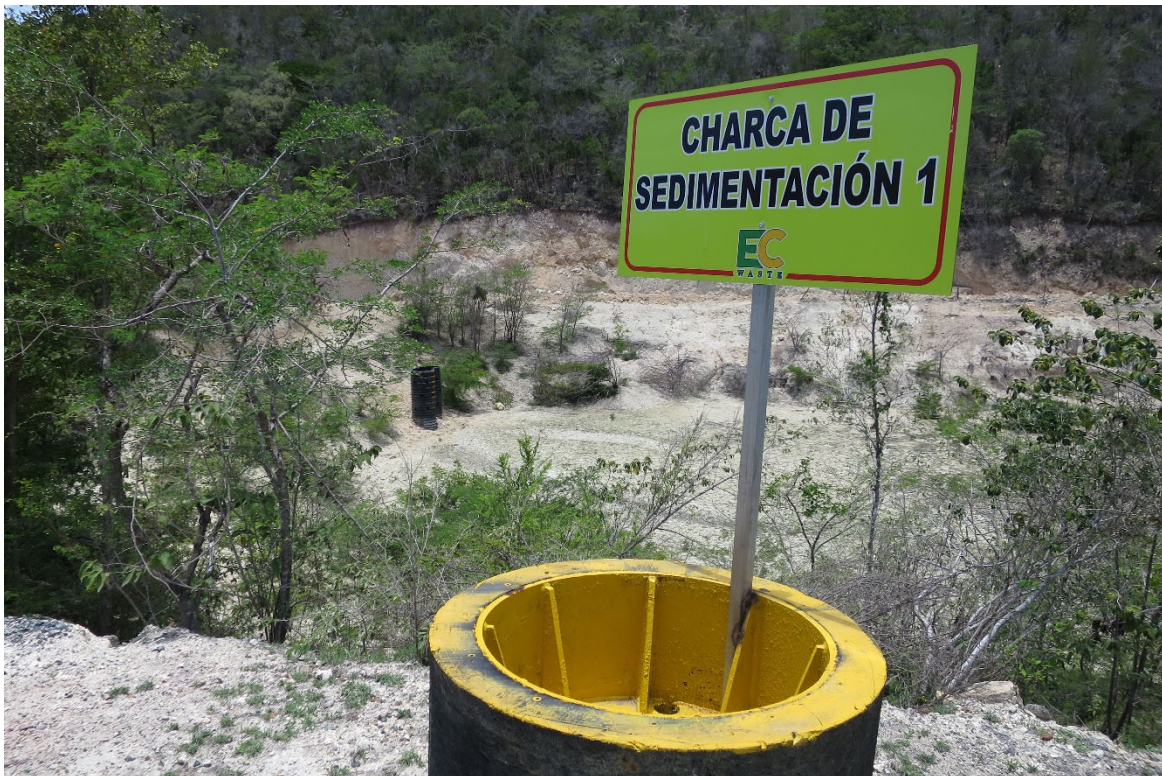
The group left the Site and drove to the parking area near the two (2) sedimentation ponds south of the Site. New signs had been posted for the sedimentation ponds (see photographs 14 through 16). These signs were not posted by the Proteco Group. de maximis conveyed to EPA Proteco Group's continued concern about the bypass canal. The bypass canal was not constructed by the Proteco Group and redirects stormwater from the EC Waste facility and the [northern] portion of the Proteco Site away from the sedimentation ponds. Zolymer stated that she would like information about the 1999 Proteco Resource Conservation and Recovery Act (RCRA) closure plan(s) and any plans/information about the sedimentation ponds contained in those plan(s). Zolymer asked if the Valdeviesos (the landowners) had approved building the sedimentation pond(s), which could not be answered by the Group representatives that attended the SRV.

Photo 14: Sign for Sedimentation Pond 1 (Lower Dam and Spillway Pipes in background)

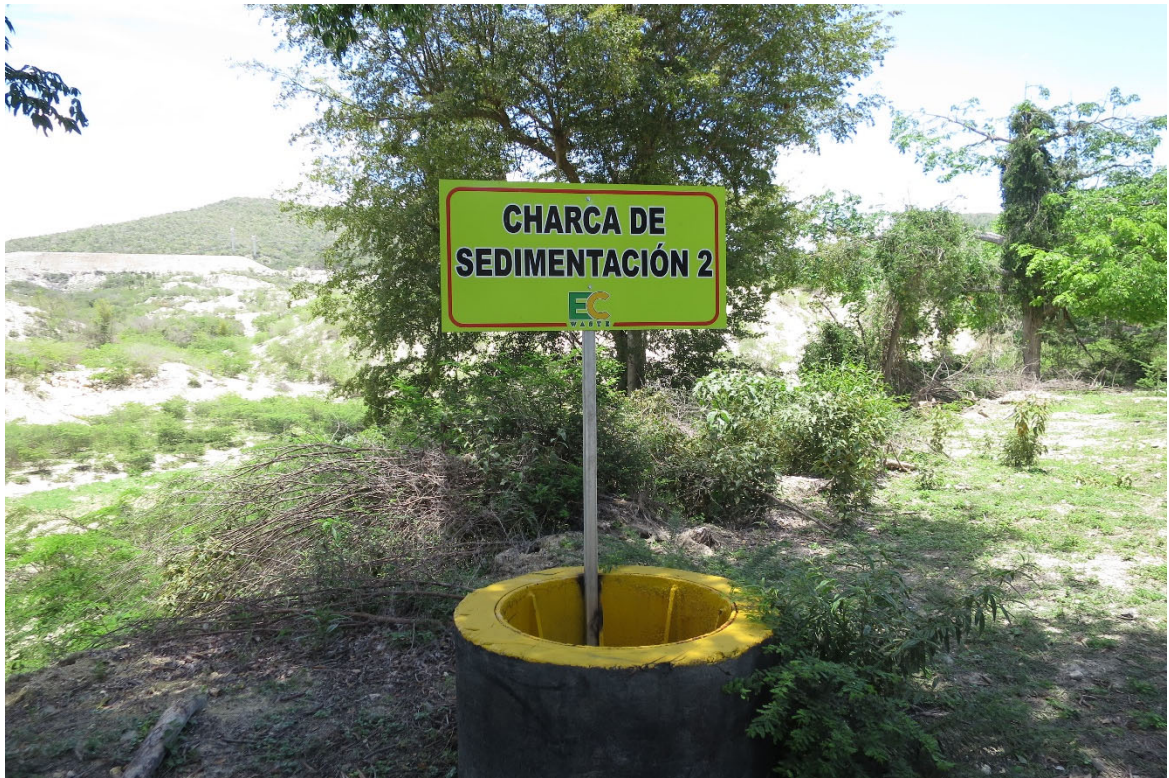
Photo 15: Sign for Sedimentation Pond 2

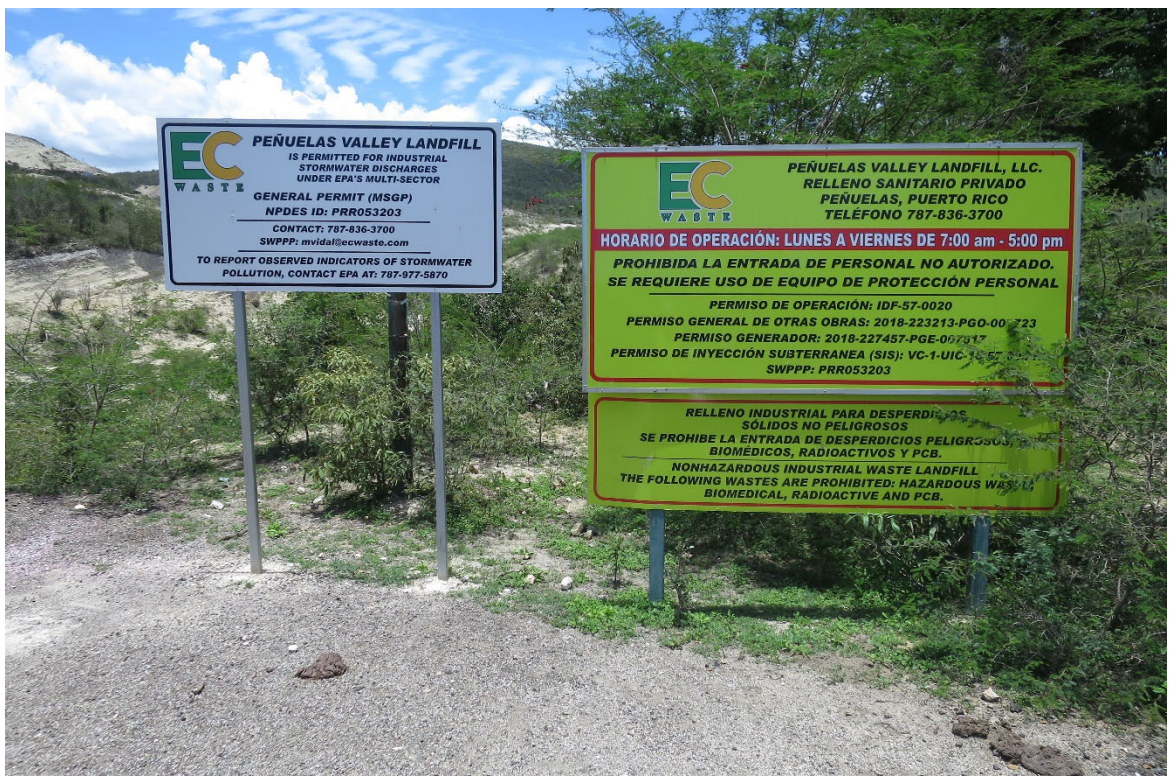
Photo 16: Signs Near Sedimentation Ponds

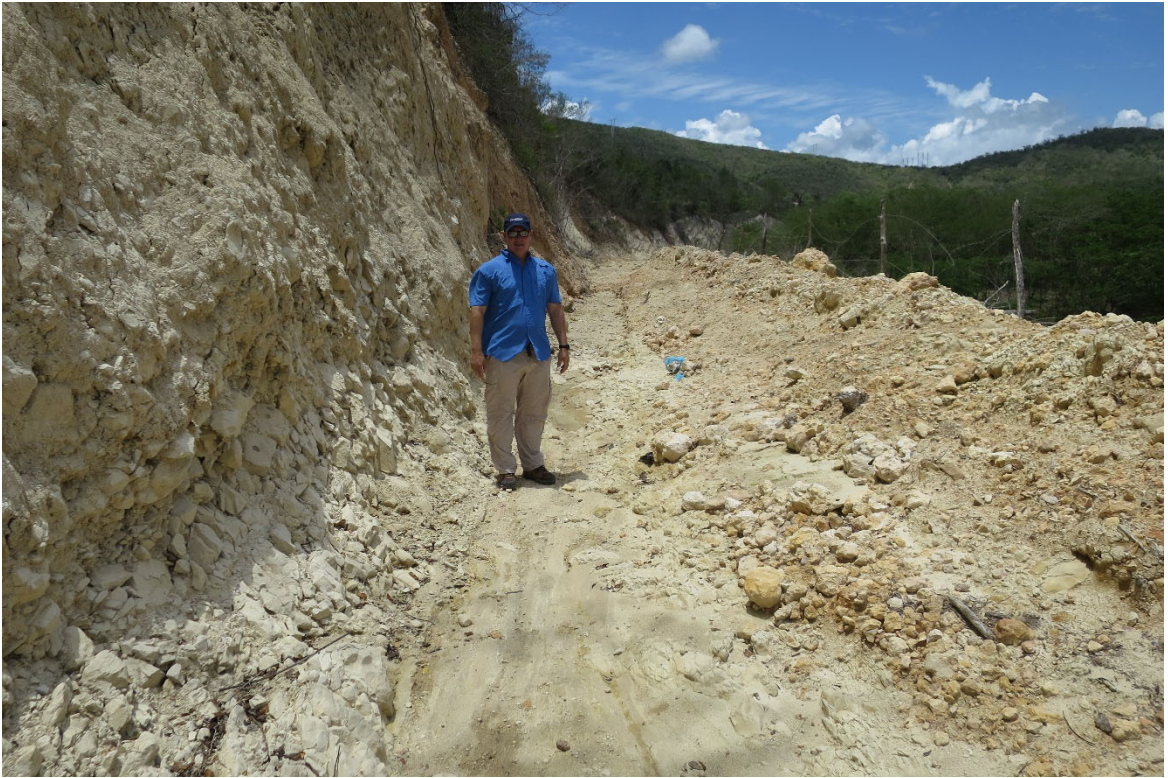
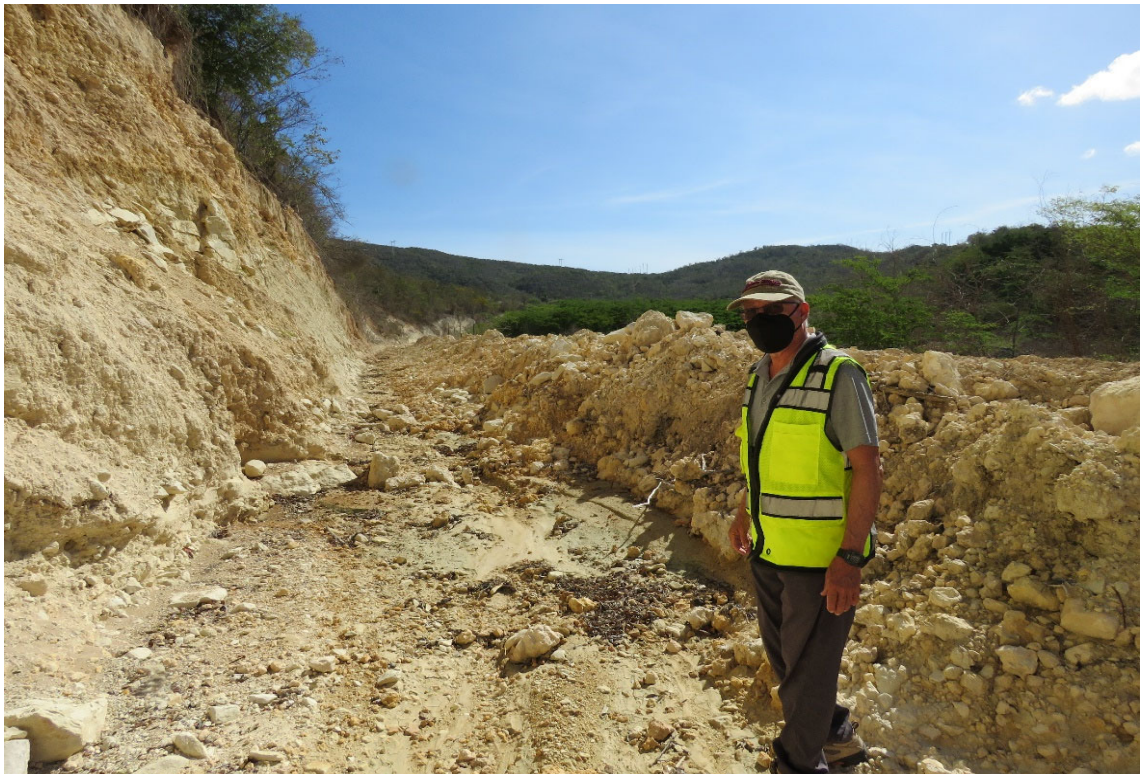
de maximis and Geosyntec walked to the bypass canal and took pictures to document the conditions on May 3, 2022 to compare them to photos taken on June 25, 2021. Photos 17 through 20 compare the condition of the bypass canal and the west abutment of the lower sedimentation dam from June 25, 2021 to May 3, 2022. The photos show that the bypass canal was still present on May 3, 2022 and is still functioning to channel stormwater from EC Waste and the [northern] portion of the Proteco Site so that it does not enter the sedimentation ponds. The photos also show the current condition of the west abutment of the lower (primary) sedimentation pond dam. The bypass canal and west abutment of the sedimentation pond dam appear to be in a worse condition than was previously reported to EPA in June 2021. It would appear that the stormwater which has flowed through the bypass canal since the June 2021 visit has eroded more soil material from the sediment pond dam's west abutment and the adjacent hillside.

Photo 17: Todd Kafka in Bypass Canal, May 3, 2022

Photo 18: Raul Colon in Bypass Canal, June 25, 2021

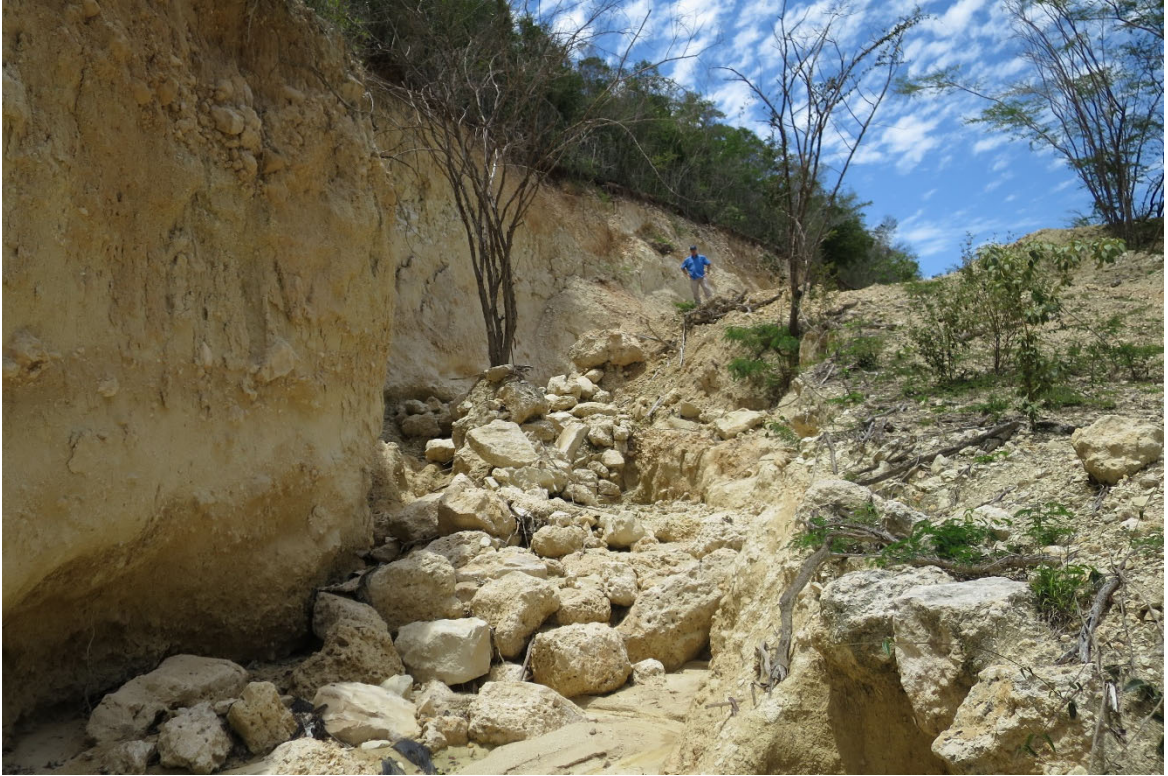
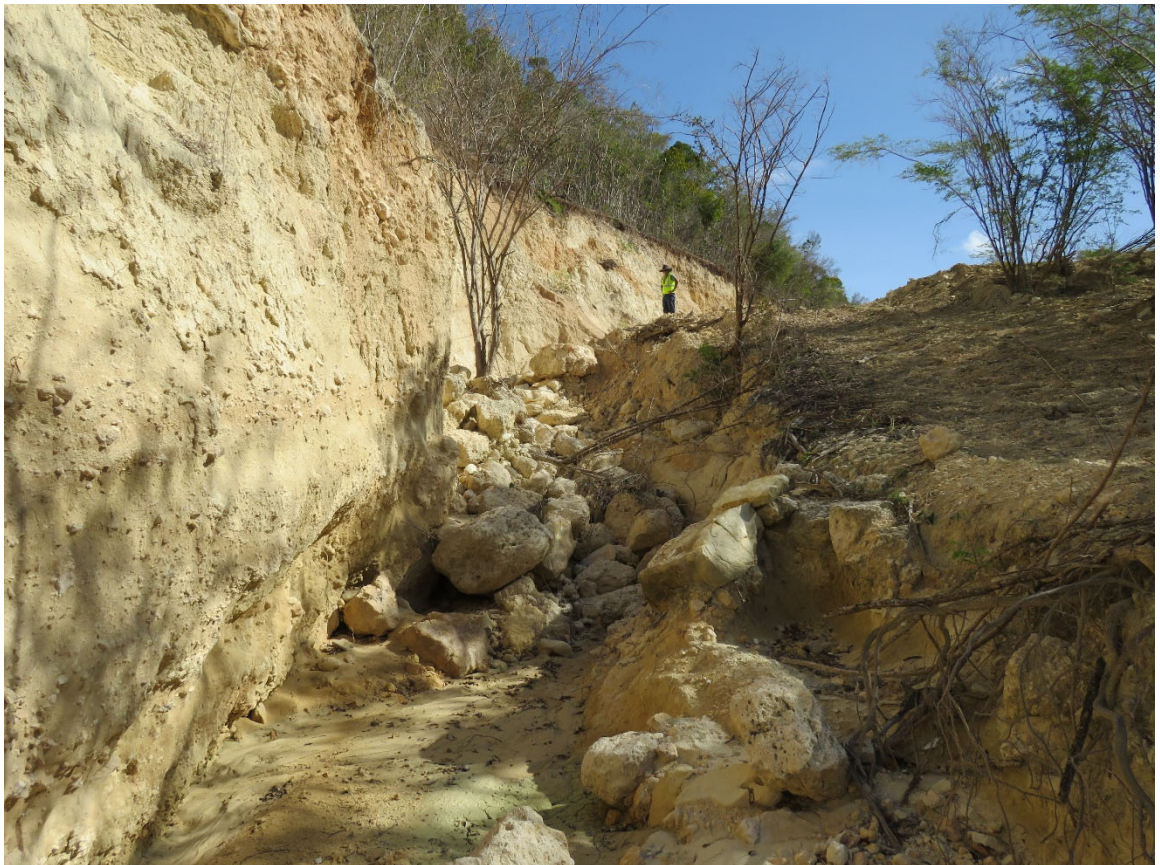
Photo 19: West Abutment Lower Sedimentation Pond, May 3, 2022

Photo 20: West Abutment Lower Sedimentation Pond, June 25, 2021
